Coal Mine Fatal Accident 2004-13

Operator:	Bell County Coal Corporation
Mine:	Coal Creek Mine
Accident Date:	June 16, 2004
Classification:	Fall of Roof
Location:	District 7, Bell County, KY
Mine Type:	Underground
Employment:	44
Production	4,000 Tons/Day

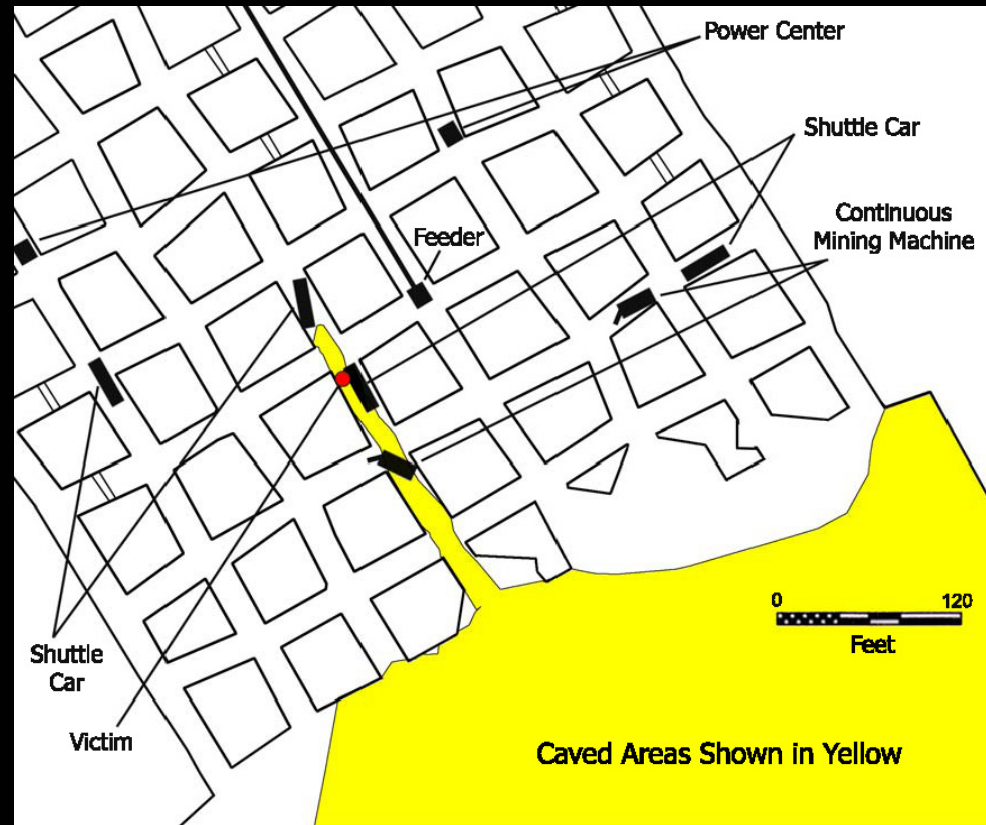
While retreat mining in the pillar block located along the left side of the No. 5 entry, the mine roof started working in the worked out area and the continuous mining machine was backed outby approximately 60 feet in the No. 5 entry. Crewmembers observed the mine roof working and the timbers taking weight while the victim, shuttle car operator/timberman, was recording the activities with his personal digital video camera.

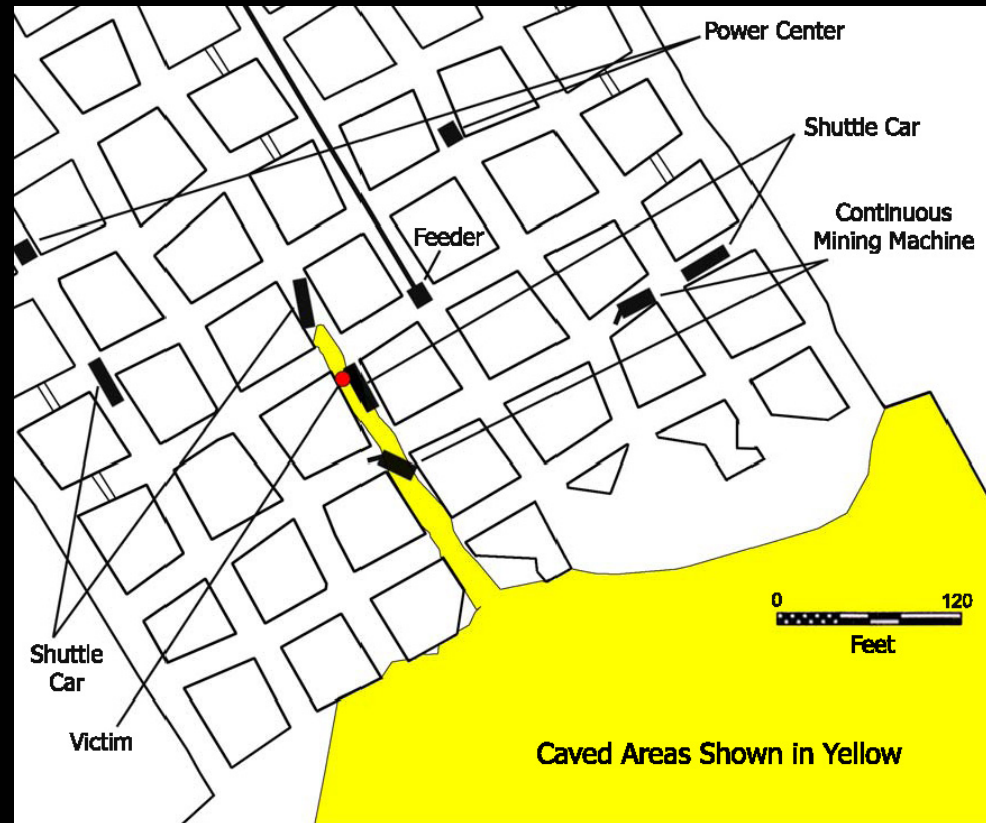
It was observed that the mine roof was working along the No. 5 entry outby the active pillar line and a roof fall was imminent. As the continuous mining machine operator began moving the machine from the No. 5 entry into the connecting crosscut toward the No. 6 entry, the victim ran in an outby direction in an attempt to escape. The roof fall began in the worked out area and extended outby in the No. 5 entry for approximately 210 feet, trapping the victim under the fallen material.

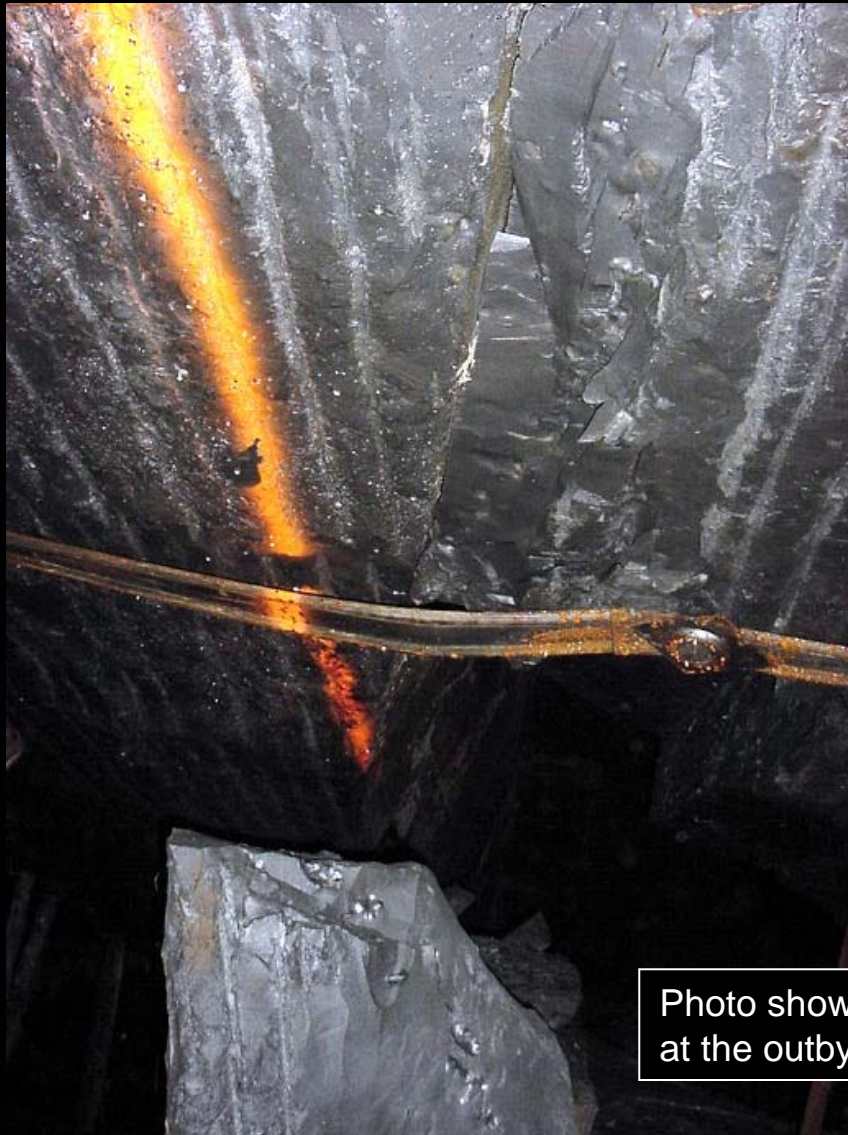
Photo shows one of the joints in the No. 5 entry, at the outby end of the roof fall.

Two large vertical joints (hillseams) running parallel to both ribs were present in the No.5 entry. The parallel joints allowed the roof fall to initiate near the pillar line and propagate outby in the No. 5 entry.

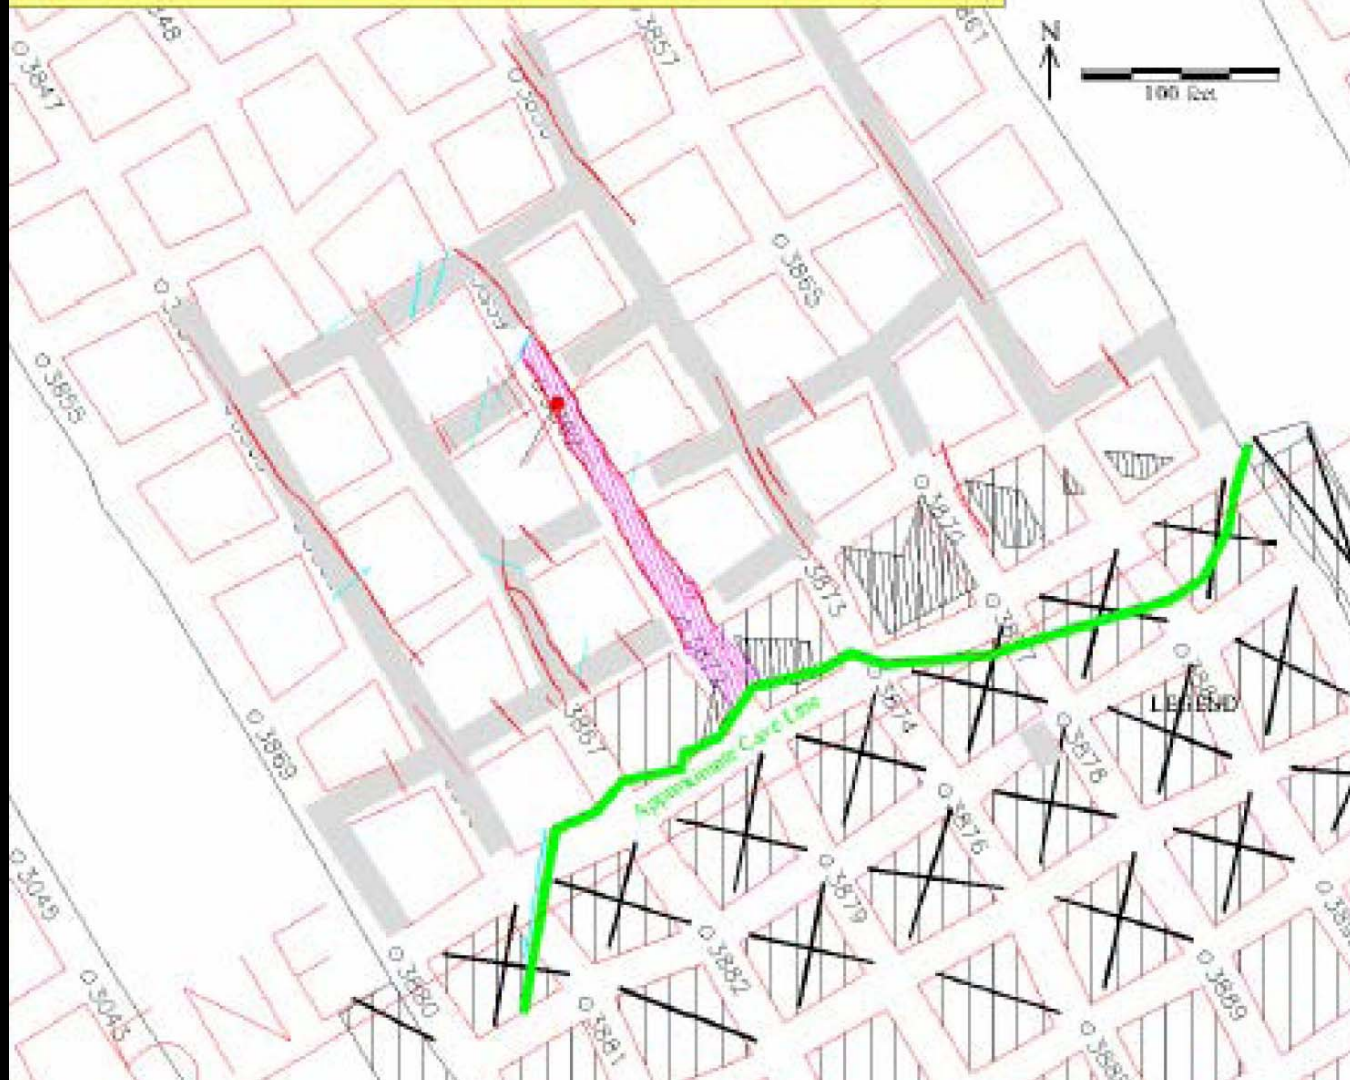
Detailed section map showing relation between lineament "5NE" and the vicinity of the cave line. Joints (thin red and light blue lines) from mapping by M. Gauna, MSHA RCD. Large red "X" is approximate victim location.

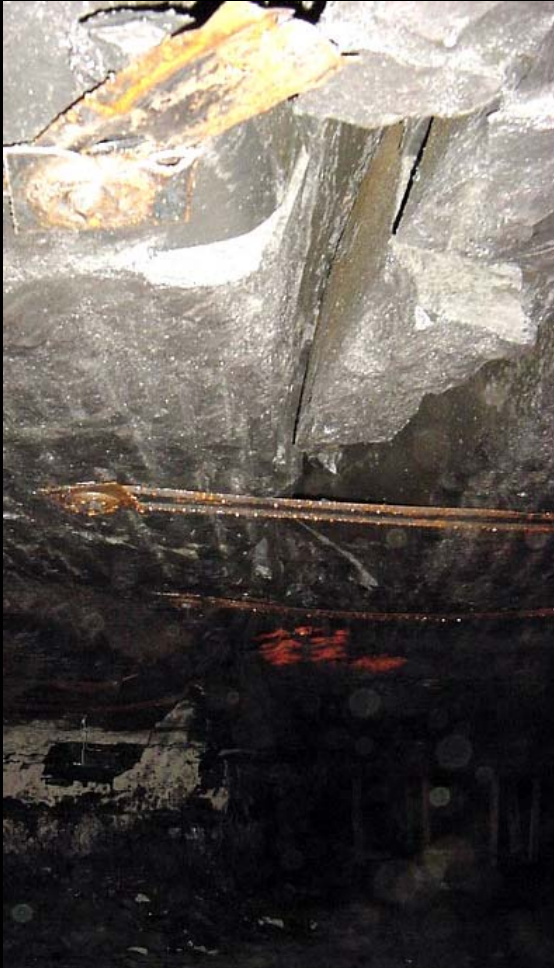
View of open joint in #6 entry, in Crosscut 13, adjacent to fall.

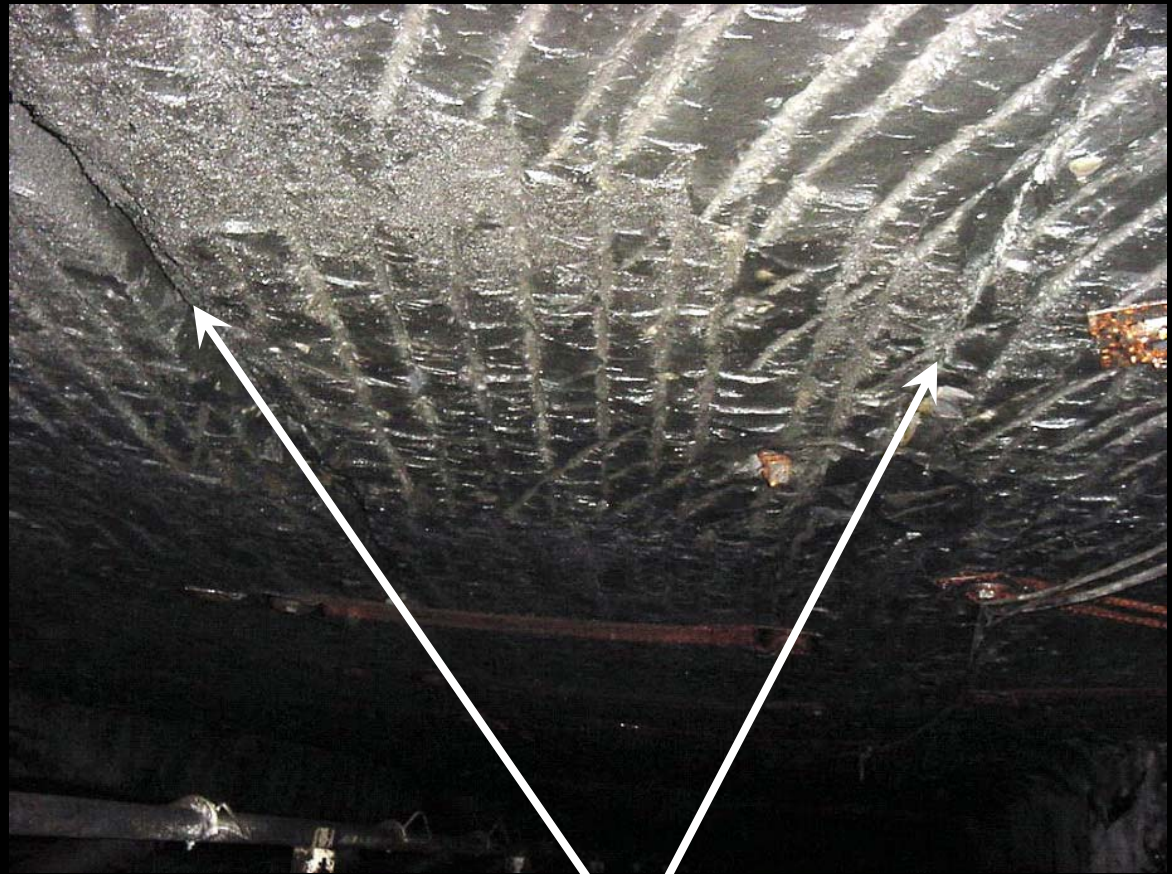
View of parallel joints, approximately 3 feet apart, in intersection of Belt Entry and Crosscut 9, two crosscuts outby feeder.
